## Morphodynamic Alterations and Scour Processes around Bridge Openings: A Case Study of Selected Bridges on the Sodo-Konso Highway, Ethiopia

### Abstract

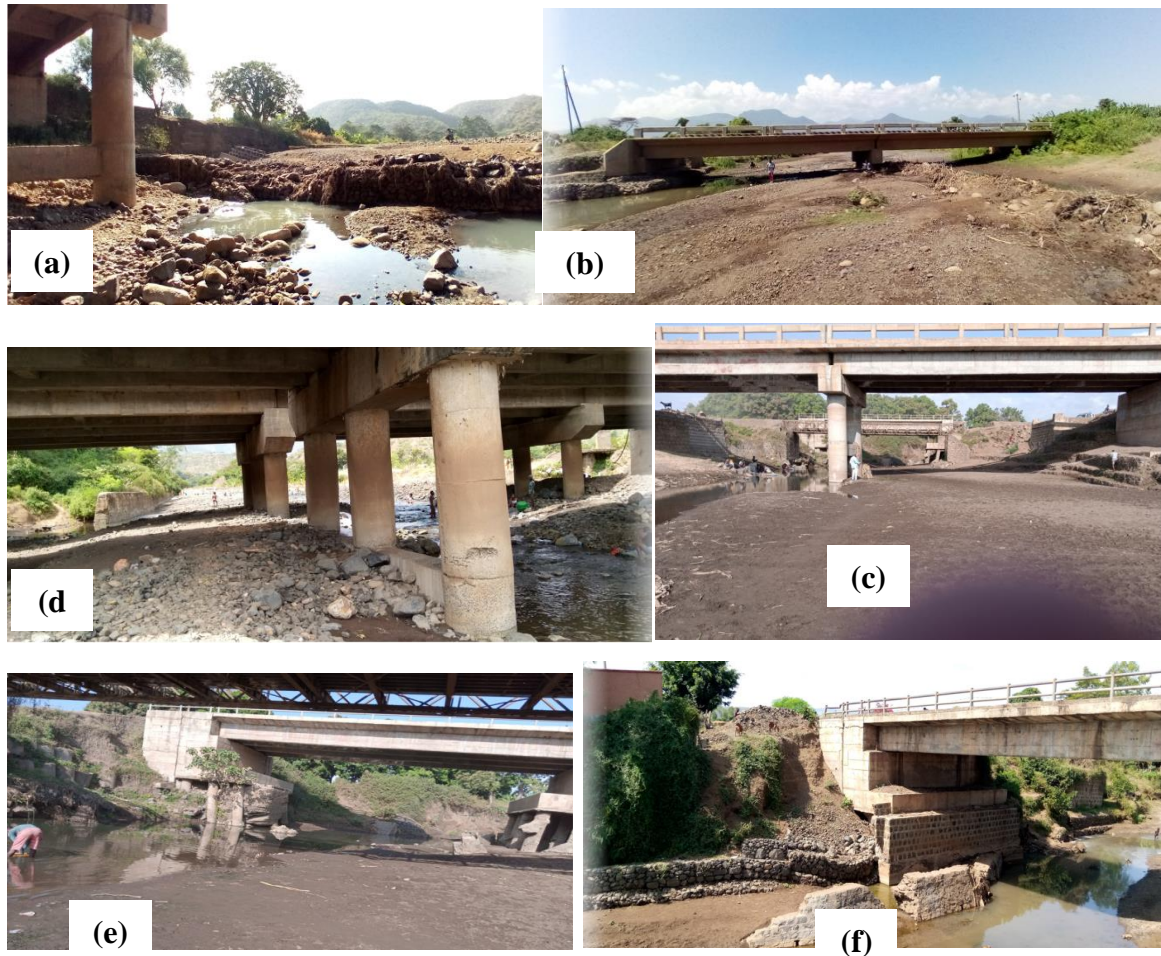
Figure 3. Scour susceptible bridges site photos

Alluvial morphodynamic awareness is important for engineering decisions regarding the analysis of new and existing hydraulic structures. Unlike geomorphologists and geologists, engineers are concerned with changes in river morphology relatively for a short period of 10 to 20 to 50 upto 100 years(R.J.Grade, 2006). Based on the field observations and scour susceptibility, five bridges namely Wajifo, Alge, Kulfo, Sile, and Sego were selected for analysis. The banks and beds of these bridge sites were relatively unstable as compared to other bridge sites as shown in Figure 3: (a) Wajifo bridge site with improper upstream gabion check dam (b) Alge bridge with channel migration to the right bank (c) Kulfo bridge with bed scour at the middle span (d) and (e), Slie bridges new and existing respectively with bank and bed scour (f) Sego bridge with left bank scour and flow obstruction due to the existing bridge abutment.

Concerning Wajifo bridge (Figure 13), pier scour is also dominant, especially within two middle spans due to the impact of a partially failed gabion check dam (Figure 3 (a)) resulting in flow complications upstream of the pier.

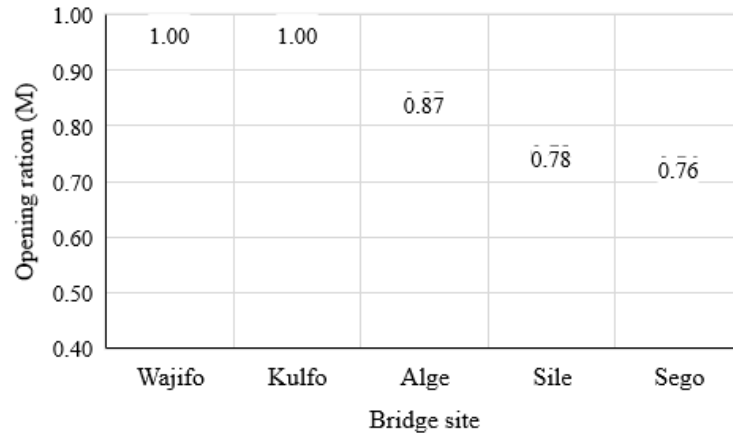
Figure 16. Bridge opening ratio for the selected sites

The major hydraulic factors for the scour problems in the selected sites are related to both the bridge structural dimension (opening ratio) impact on the flow and the nature of the channel reach geomorphology. The bridge opening ratio (ratio of discharge passing through the bridge opening location before construction to the total flow confined within left up to right abutment after the bridge construction) influences most of the selected bridges. The opening ratio ranges from 0 to 1, representing extremely narrow flow constriction resulting in high afflux and contraction scour to the abutments constructed on the full width of the flood plain experiencing lower contraction scour depth. The minimum opening ratio shows that the natural flood plain is more narrowed (Figure 16). On Wajifo and Kulfo bridge sites, the original flood plain was not narrowed during the construction of the bridge, but in Sego the constriction is higher (minimum opening ratio), resulting in high afflux (Figure 9 (a)) and Sile (Figure 17 (a)) and Alge (Figure 17 (b)) also this factor impacts the flood plain. Even though the narrow opening of the bridge is economically viable, it induces high contraction scour.

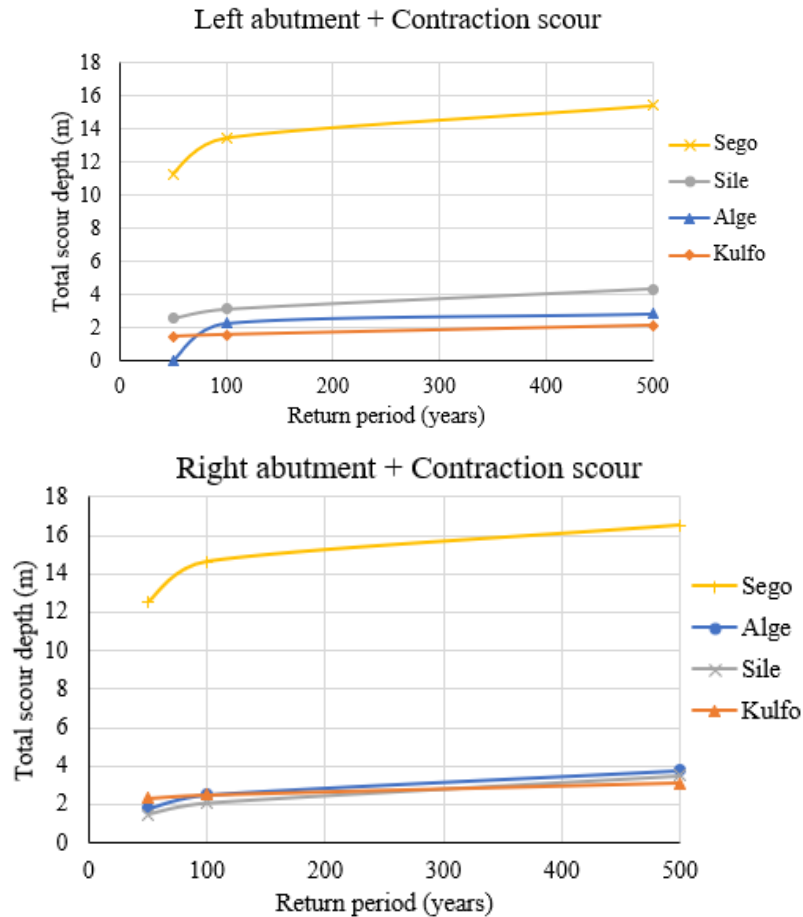
Figure 19. Total abutments scour at the selected sites

The result of the total abutment scour depth (Figure 19) showed that both abutments of the Sego Bridge were highly scouring susceptible as compared to others. In the site of Sile, the left abutment was more susceptible to the migration tendency of the channel to the left bank in the downstream vicinity of the bridge. The right abutment of Alge Bridge was susceptible as the flow channel was confined to the right bank throughout time. The total scour depth obtained in this analysis could be interpreted as overestimated values rather than the actual values (Cooperative et al., 2006; Hong & Abid, 2015) due to the effect of scaling in analysis equations. The relative importance of the highway route was based on the ADT Significant factors influencing the frequency of inspection strategies in a plan of action (FHWA, 2009). In this connection, the relevance of the Sodo to the Konso-Jinka federal highway was not compromised. Therefore, the Sile and Sego bridges had critical scour, demanding timely, frequent scour inspection and monitoring.

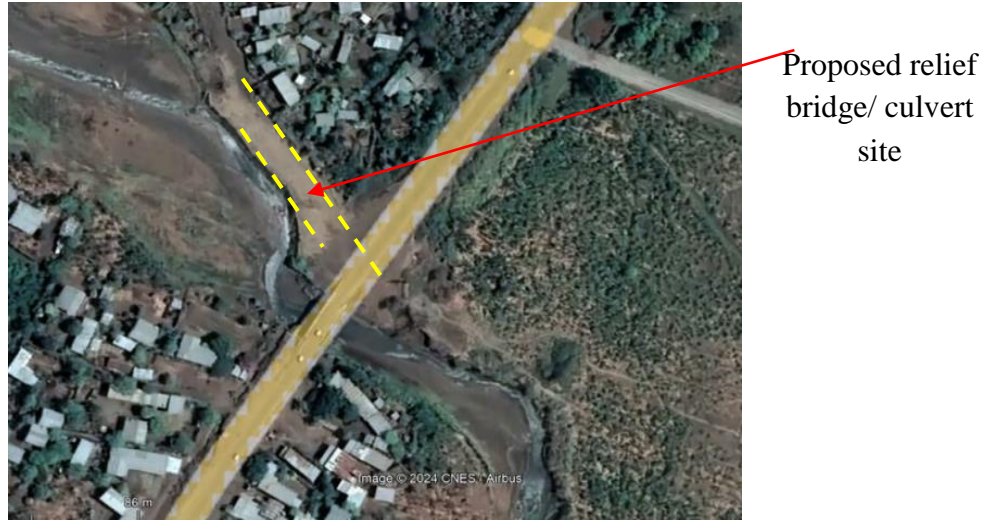
Figure 20. Proposed relief bridge or culvert site at Sego

According to the analysis, Sego Bridge was adversely affected by the contraction scour. In this case, a relief bridge or culvert near the left bank was alternatively needed to alleviate the contraction of the flow (Figure 20). Gabion check dam across the bed of the channel would prevent degradation of the bed.
